**TECMA** S.r.l.

# Case Study

## 24" Weld Wrap

24" Transmission Pipeline

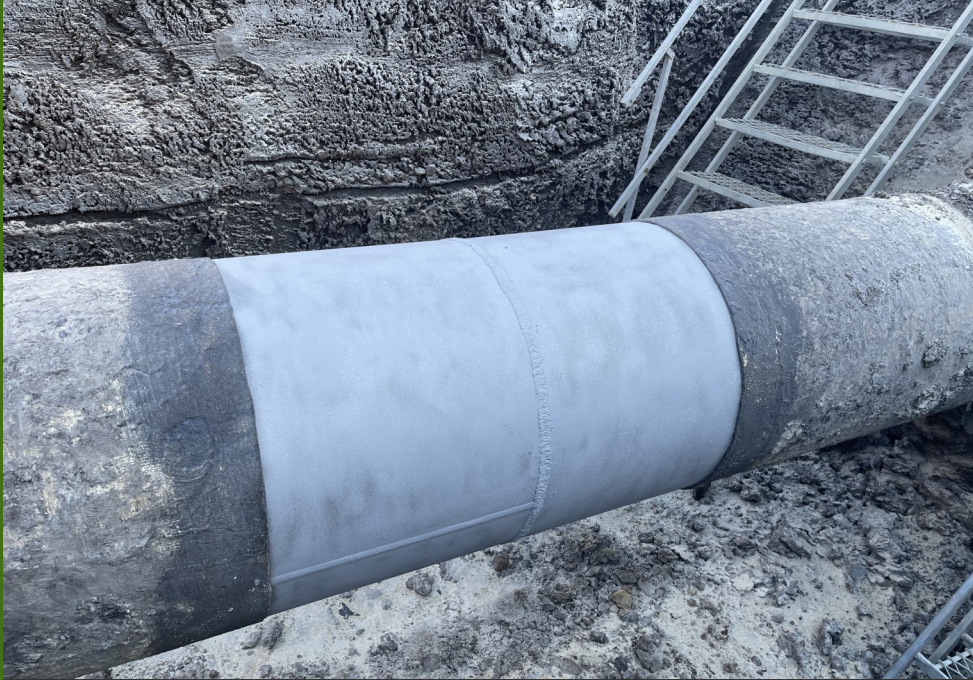
Defect weld grit blast and cleaned with acetone

Prepare surface to a minimum roughness of 50  $\mu\text{m}$  by Grit Blasting.

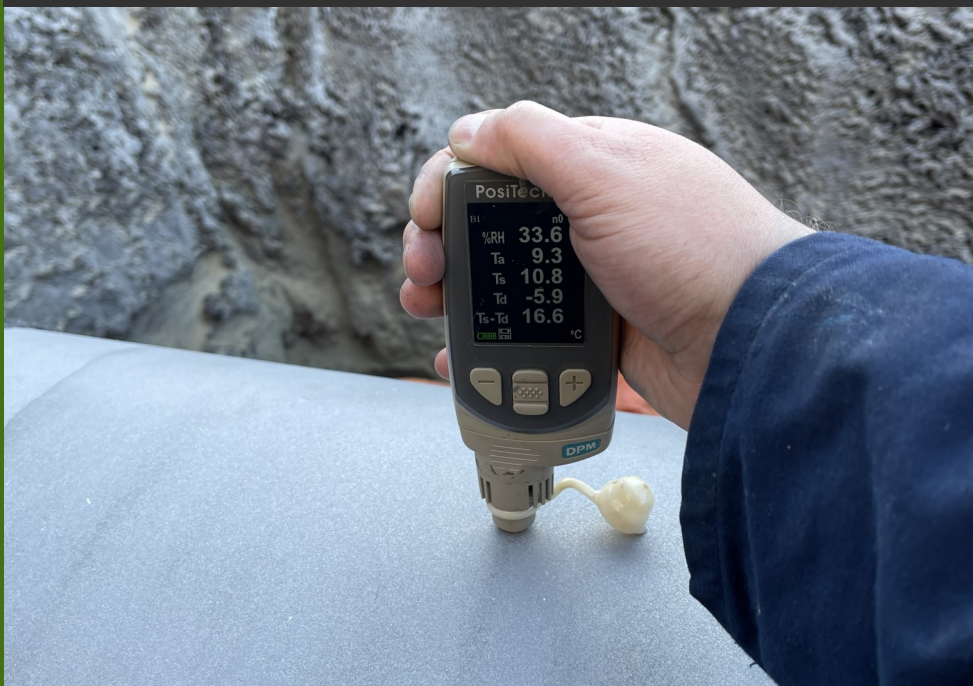
Quality inspection including surface roughness

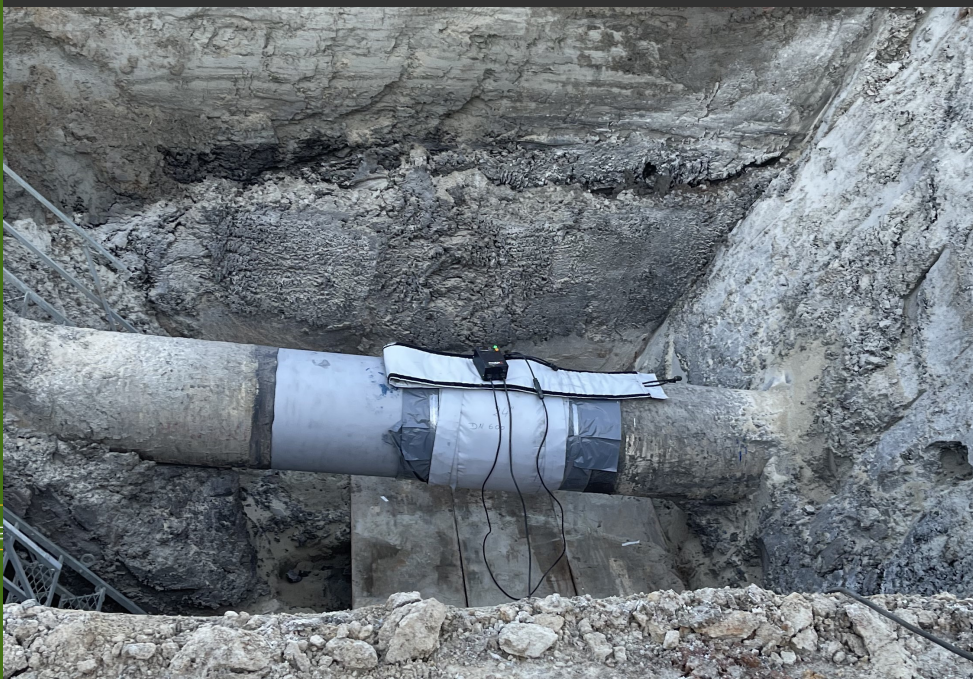
Repair installed below freezing so cured under a heat blanket

Composite cured under a 110 V heating blanket as the ambient temperature was  $-7\text{ }^{\circ}\text{C}$  throughout the installation
