www.tecma.it

Advanced composites repair

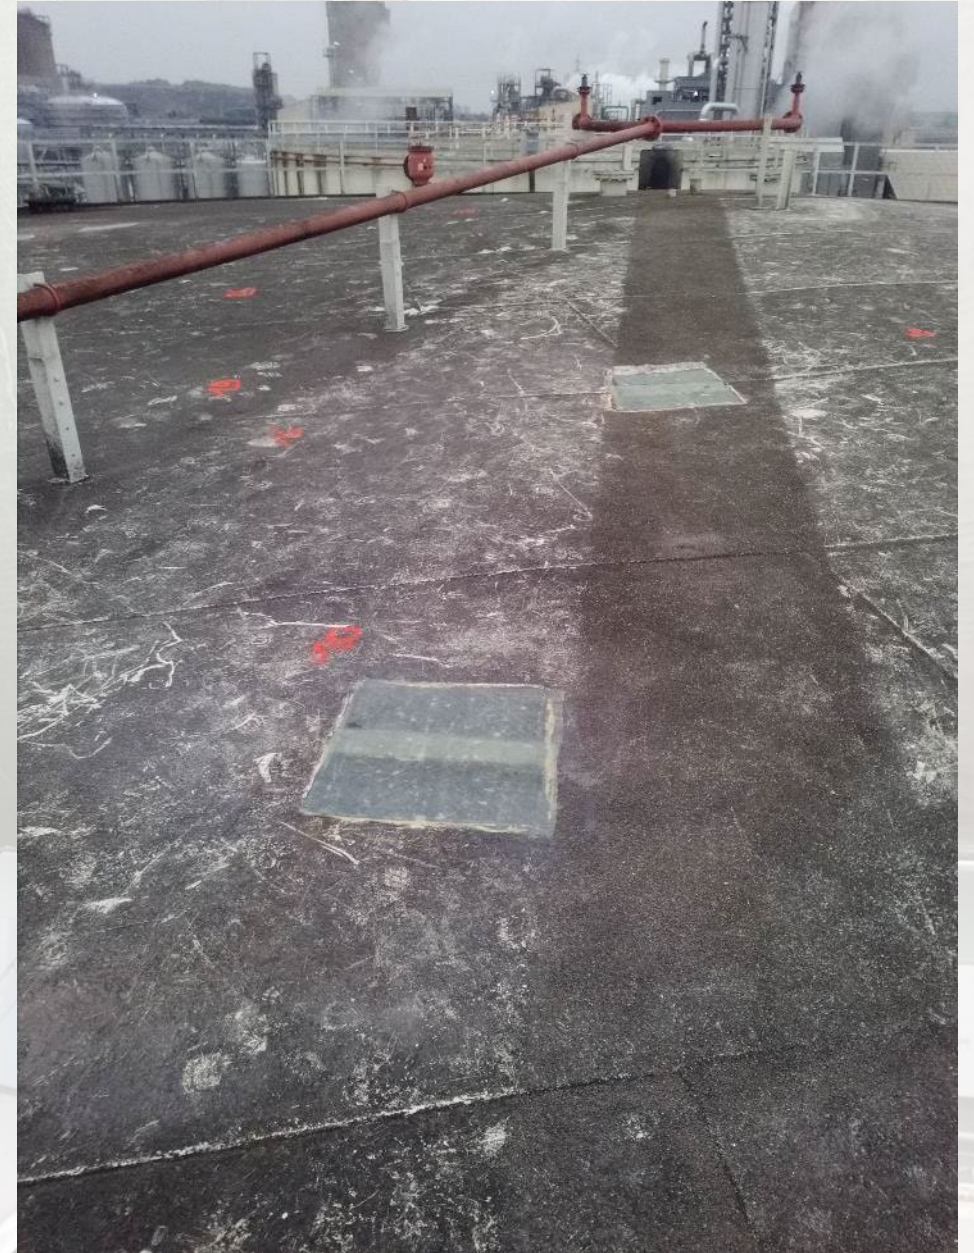
Case Study

- Tank Roof in Europe
- External corrosion patches a concern.
- 5 layers of Carbon installed and covered with 1 layer of glass fibre.
- Designed to restore original strength of tank roof
- 61 patches installed

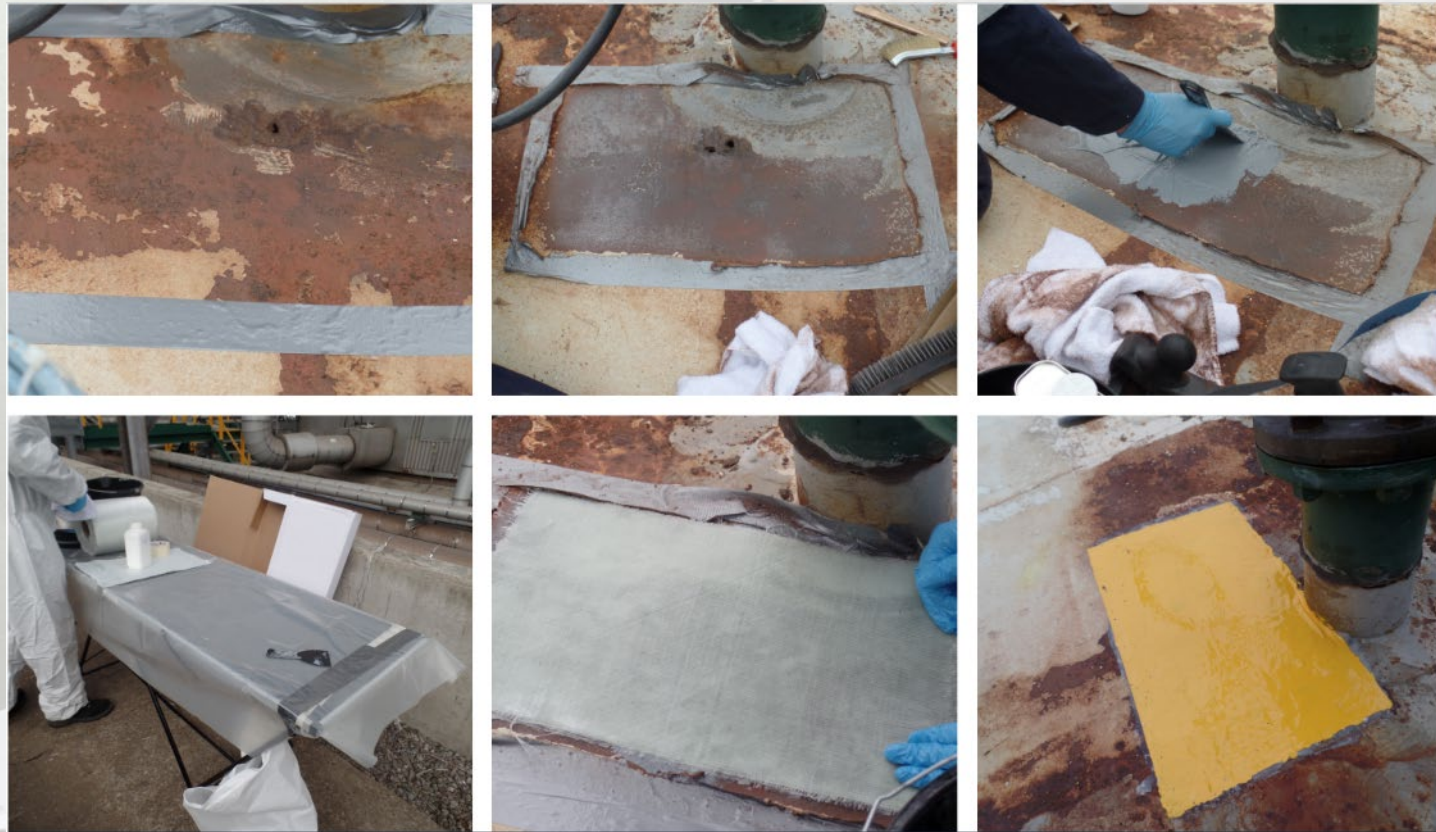
Case Study

- Tank Roof in UK
- Leaking hole defect
- 4 layers of Glass Fibre Wrap
- Designed following ISO 24817 / API 653
- Installed with local support

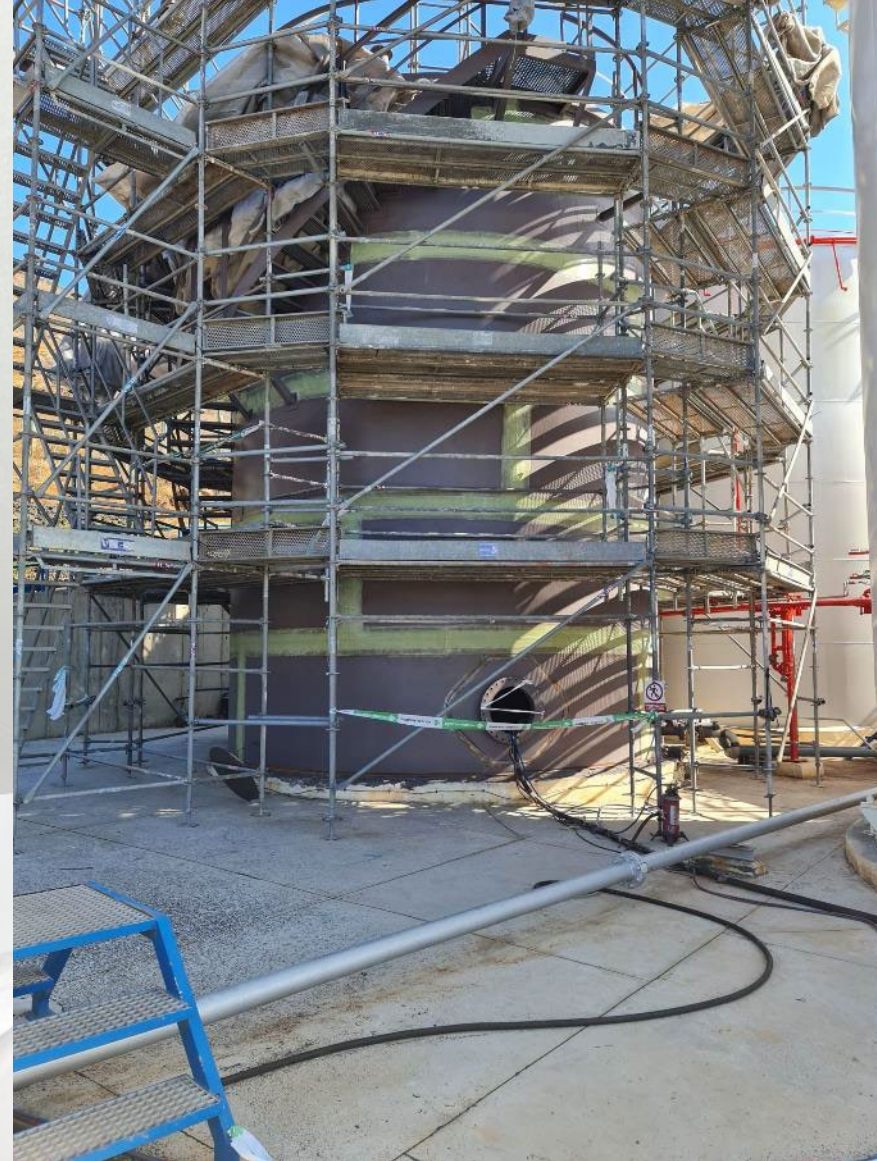
Case Study

- Tank in Canary Islands
- Lack of Fusion in welds
- 114 linear meters wrapped
- Repair designed to ISO 24817 / API 653
- 20 year design life
- Local Installation Support

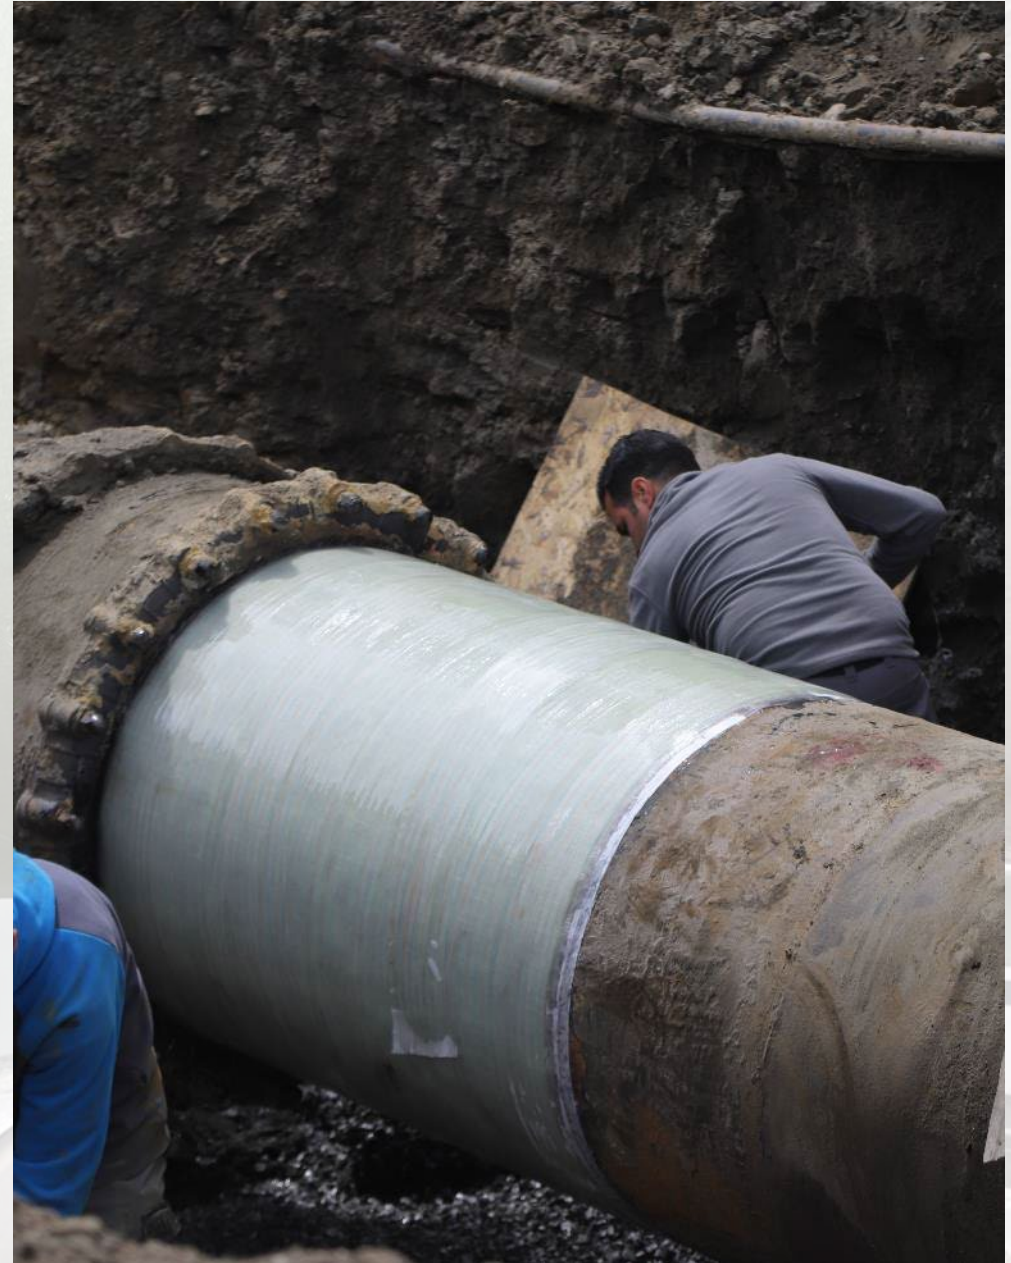
Case Study

- Water Line in Europe
- External Corrosion on cast iron
- Repair designed to ISO 24817
- Repair installed with local support
- Over 30 locations completed

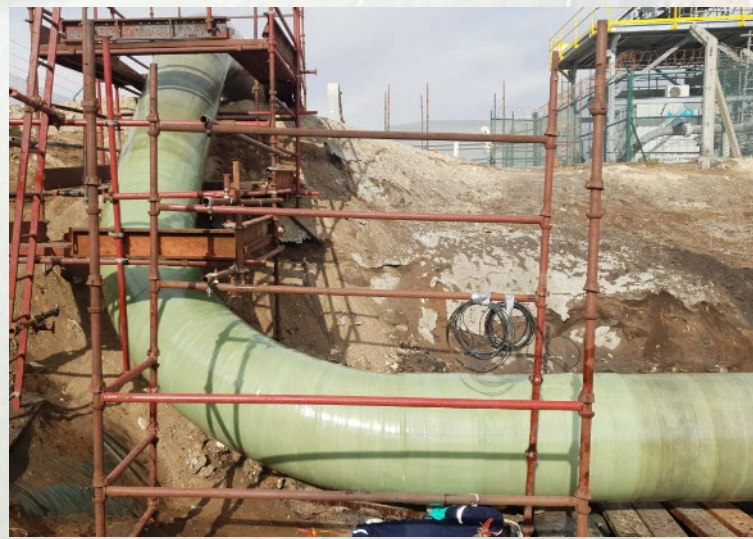
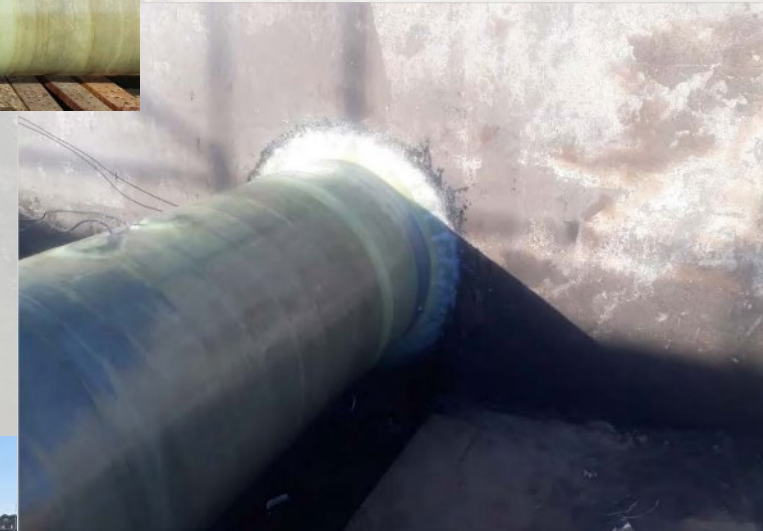
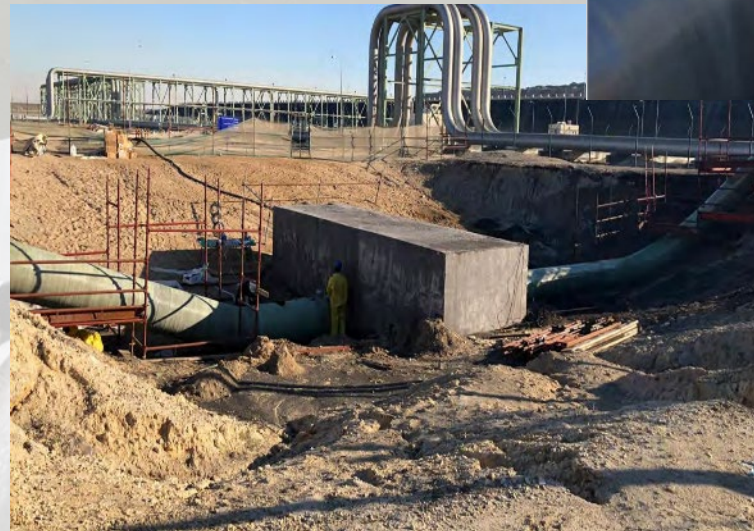
Case Study

- Refinery Crude Oil Pipeline Middle East
- 36" Diameter
- External Corrosion in Sabkha soil
- Repair designed to ISO 24817
- Repair installed with local support
- Over 30m of pipeline reinforced and protected from corrosion.

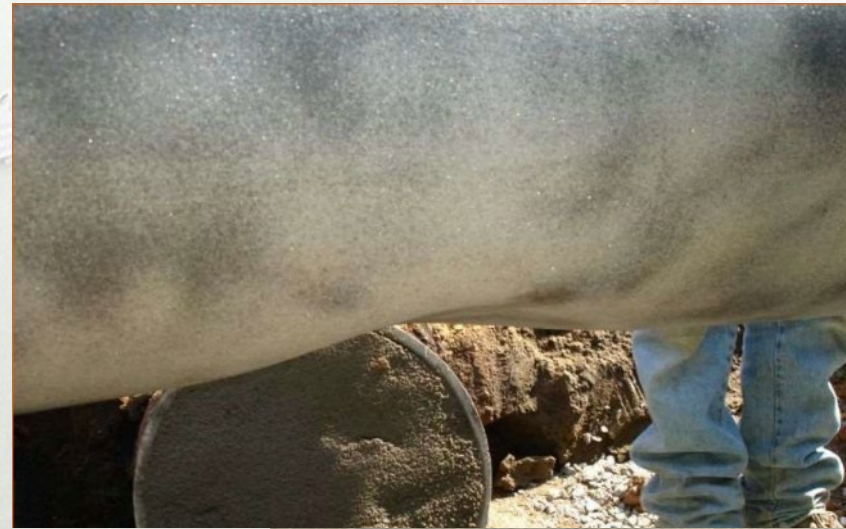
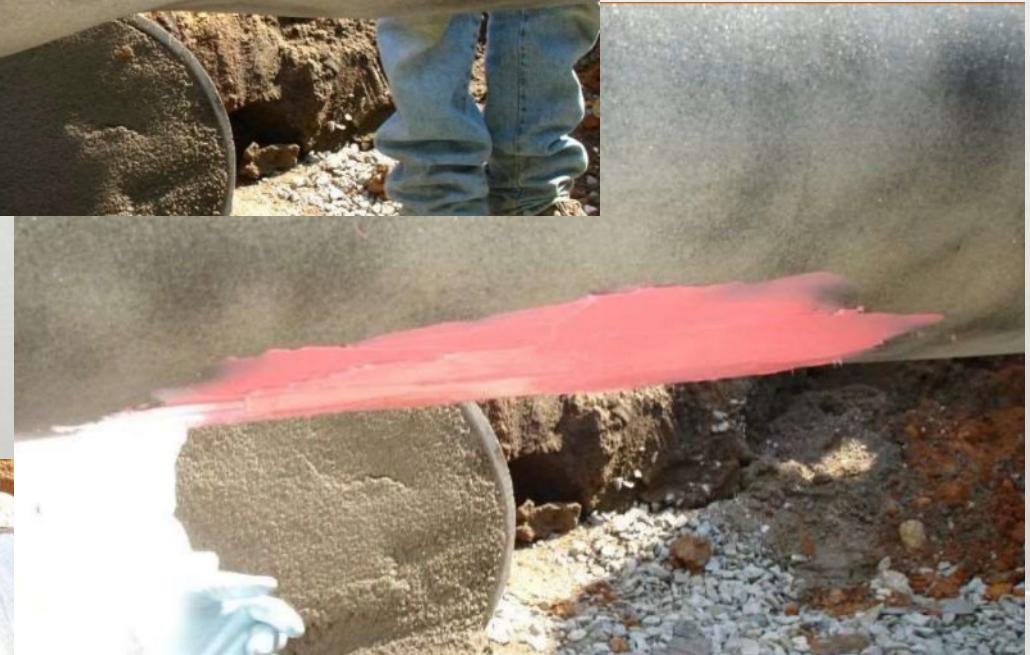
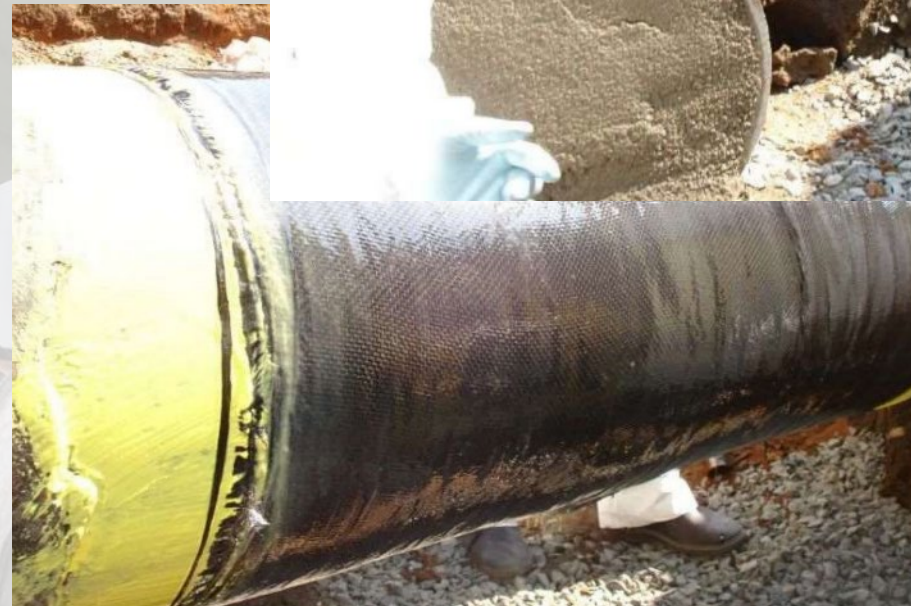
Case Study

- 16" Mixed Pipeline, USA
- High Pressure – Liquid Pipeline
- Dent under highway
- Design: 64 BarG.
- Number of cycles: 150,000

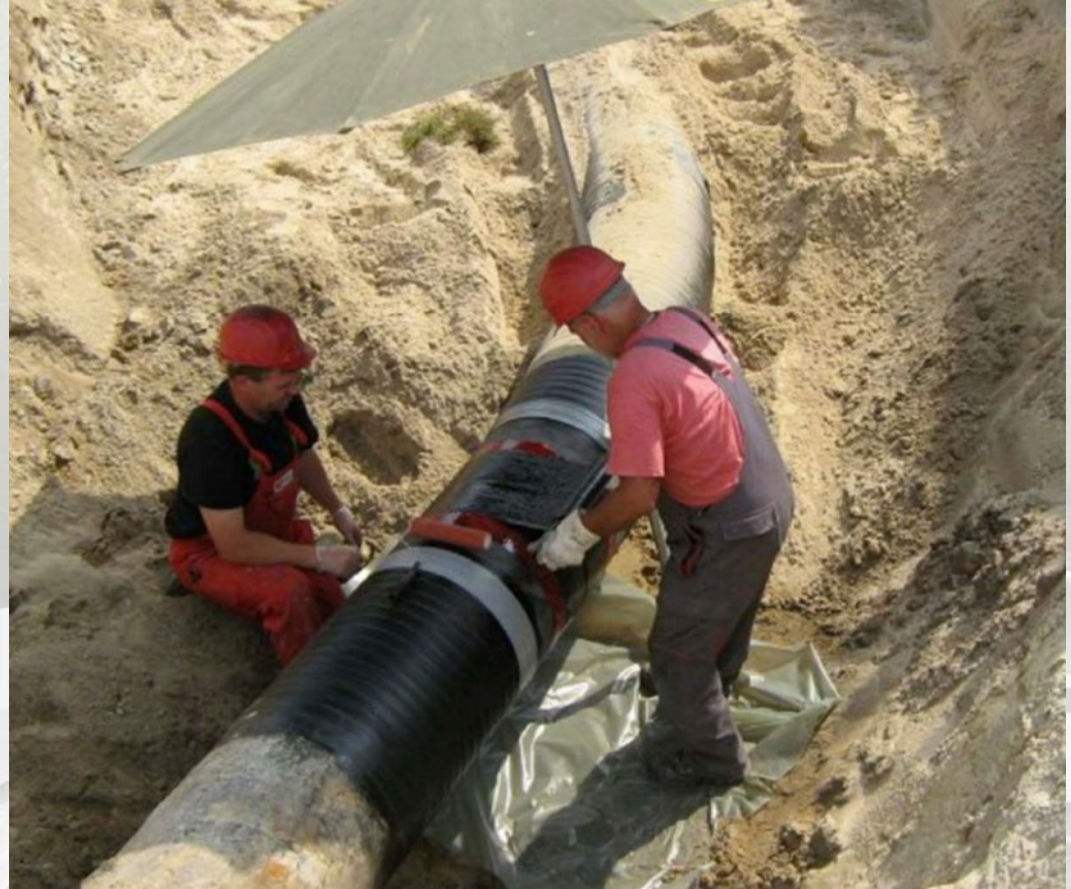
Case Study

- 20" High Pressure Gas Interconnector.
- External Corrosion on X70 Pipe
- 56% defect depth.
- 156 BarG Operating Pressure
- Critical to current EU Gas supply

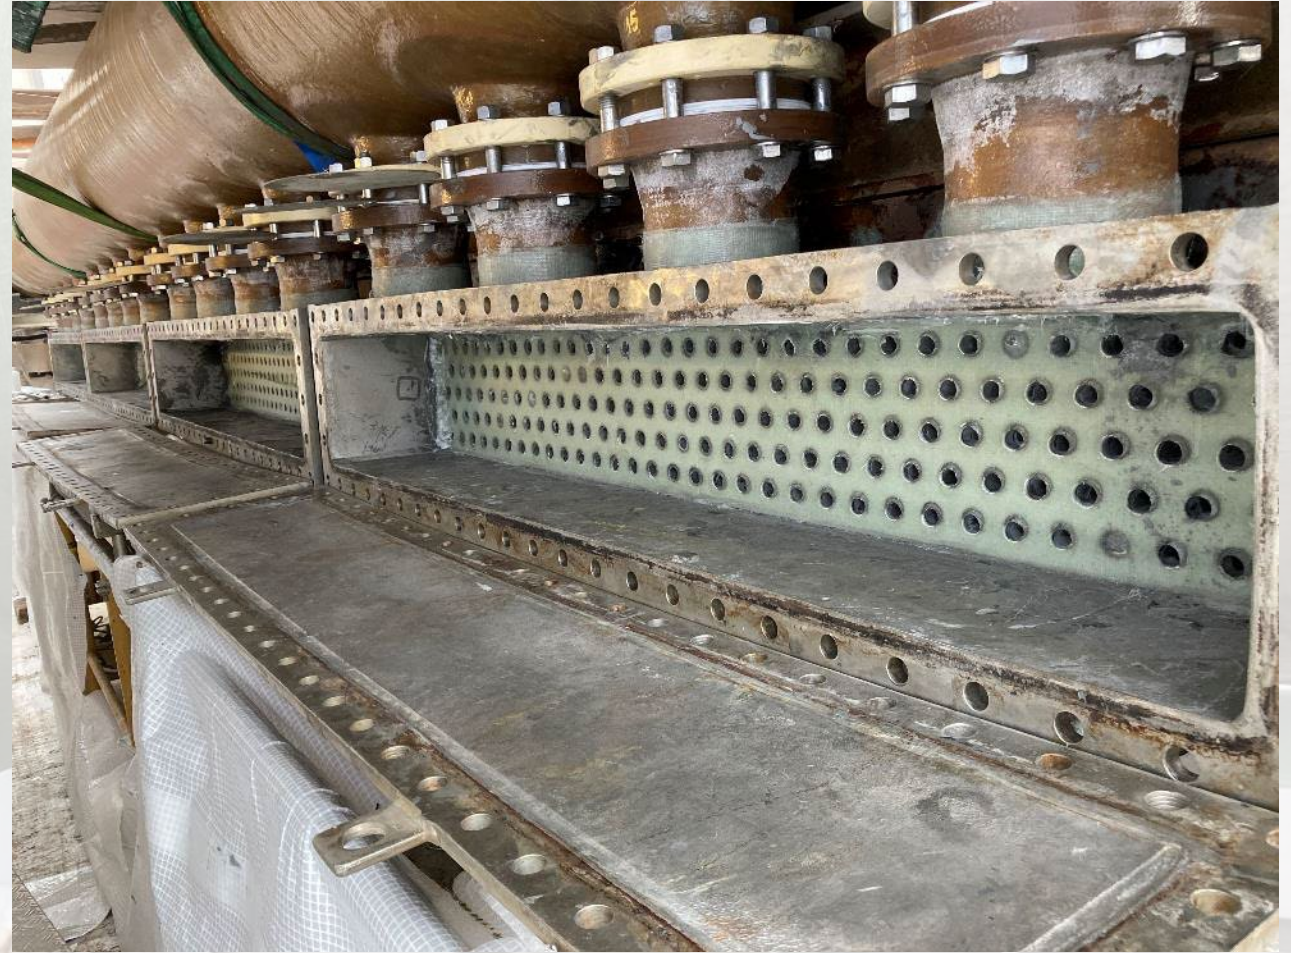
Case Study

- Heat Exchanger in Europe
- Chemical attack on the steel was impacting reliability
- Temporary fix to keep the plant reliable

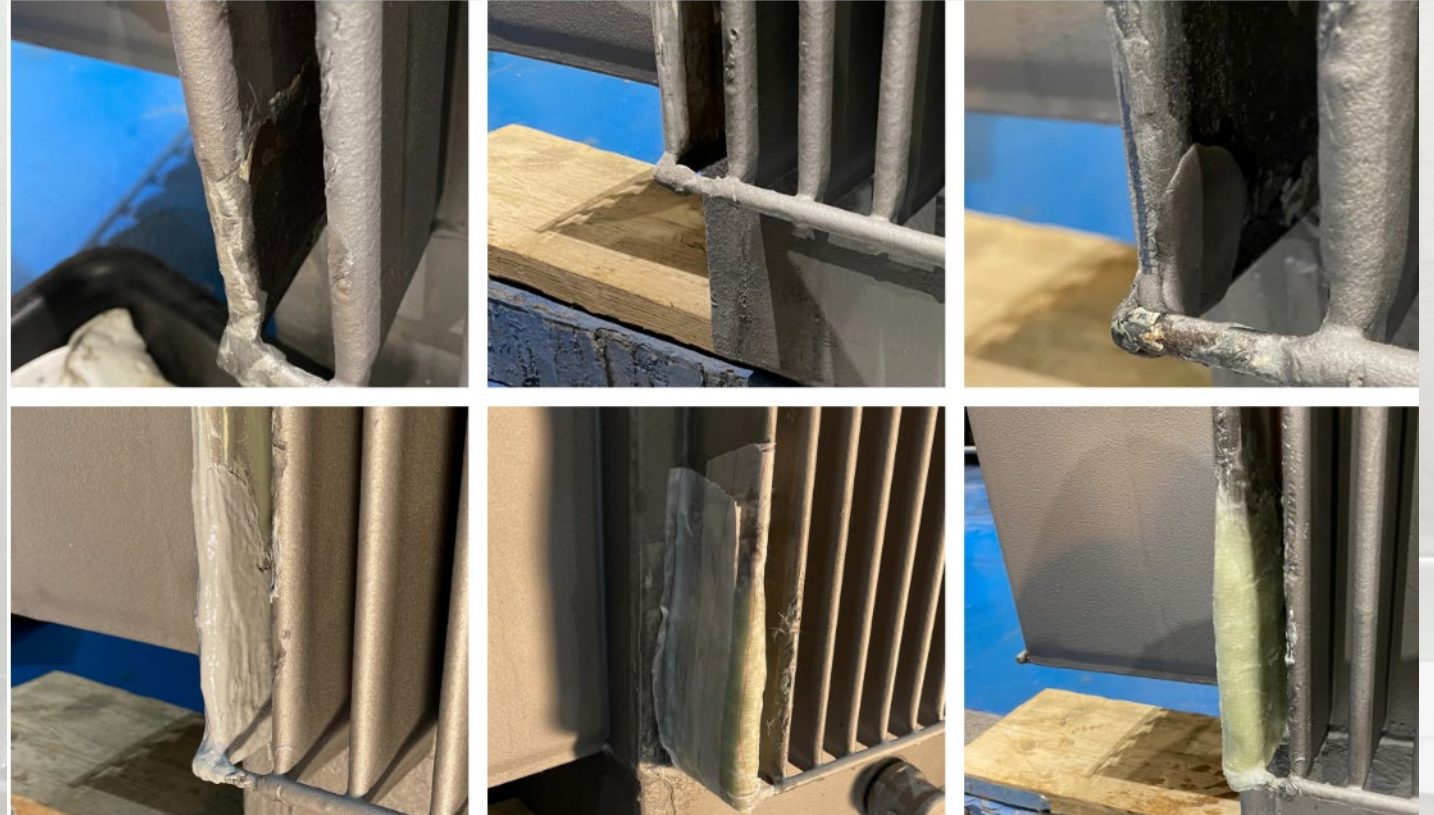
Case Study

- Heat Exchanger
- Leak caused by external corrosion.
- 4 layers of Titanium wrap installed with local support

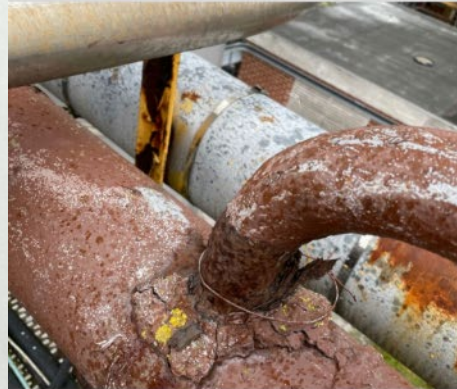
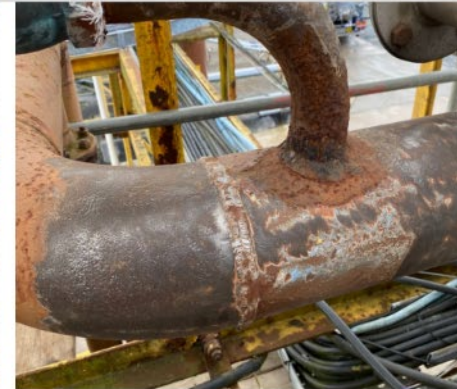
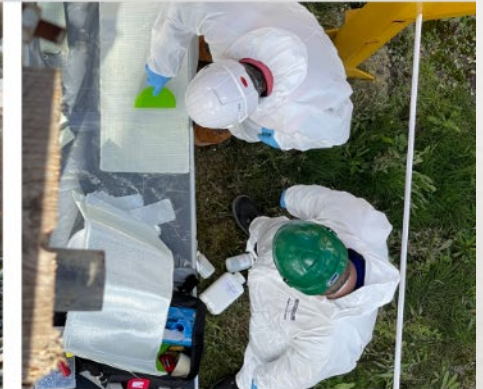
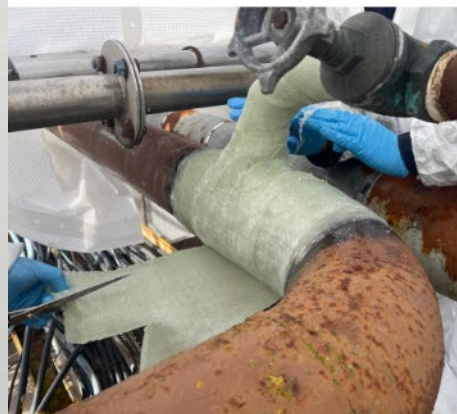
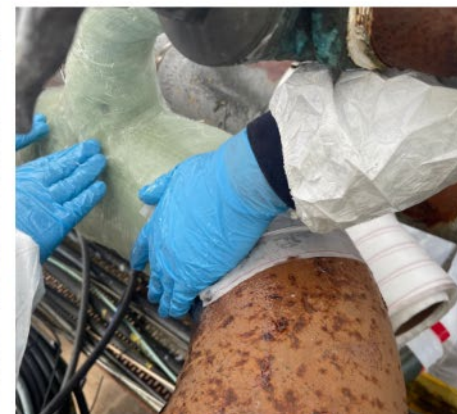
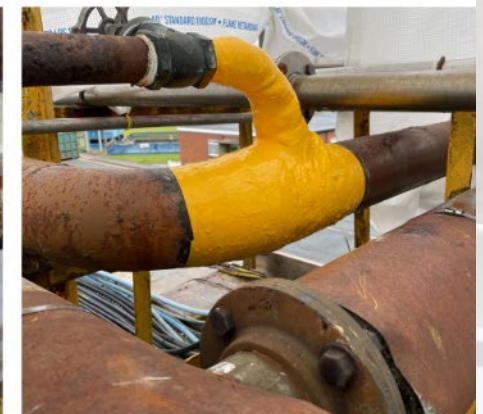
Case Study

- Air line
- External corrosion
- Leak
- Designed to ISO 24817
- Installed with local support.

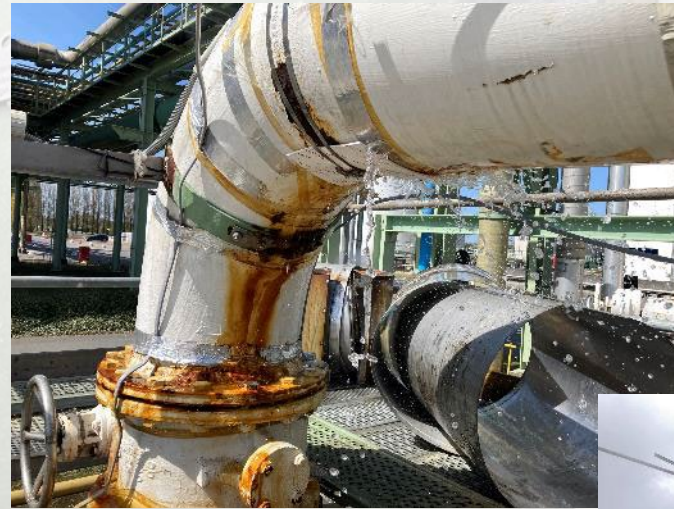
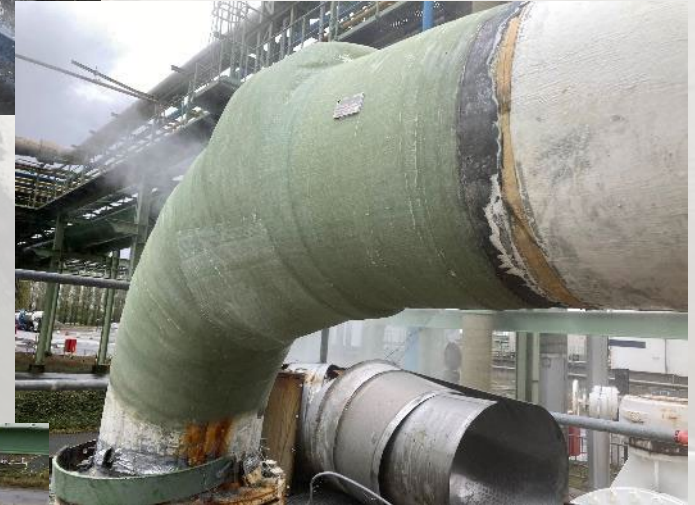
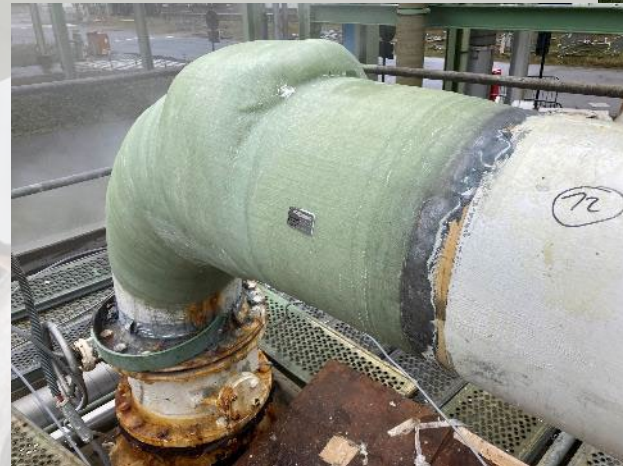
Case Study

- Refinery water line
- Internal Corrosion
- Leaking 1.5 BarG
- Designed to ISO 24817
- Installed with local support.
- 12.6 mm thick repair.
- Pipe in service throughout repair
